## 14 Island Lake Dam Inspection Report

Date: 2009 July 16 – 11:00 AM

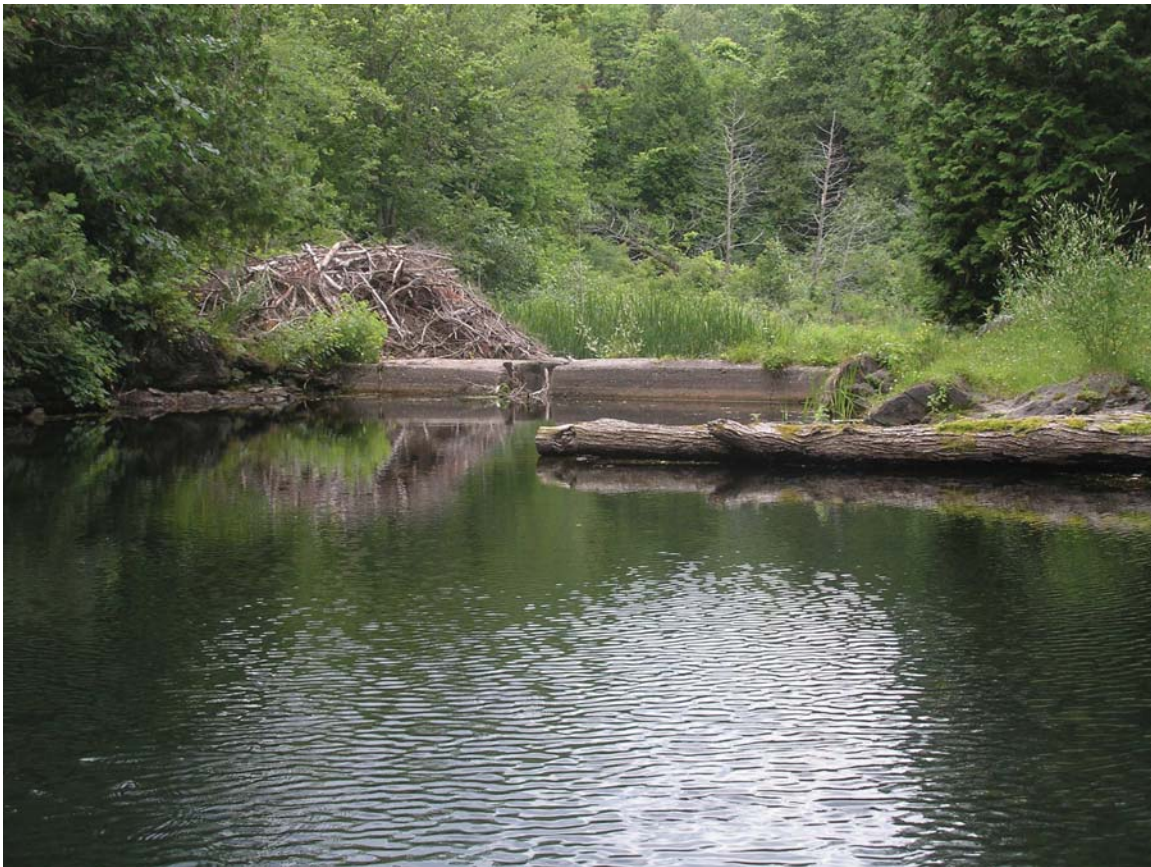
**Figure 1: Upstream View of Dam**

The dam is a concrete gravity structure approximately 6' high x 21' long x 5' thick (see Figure 1). The sluiceway opening is 2.5' and is controlled by stop logs made of dimensional 2" lumber. The stop logs appeared to be 2 x 10 (8?) material.

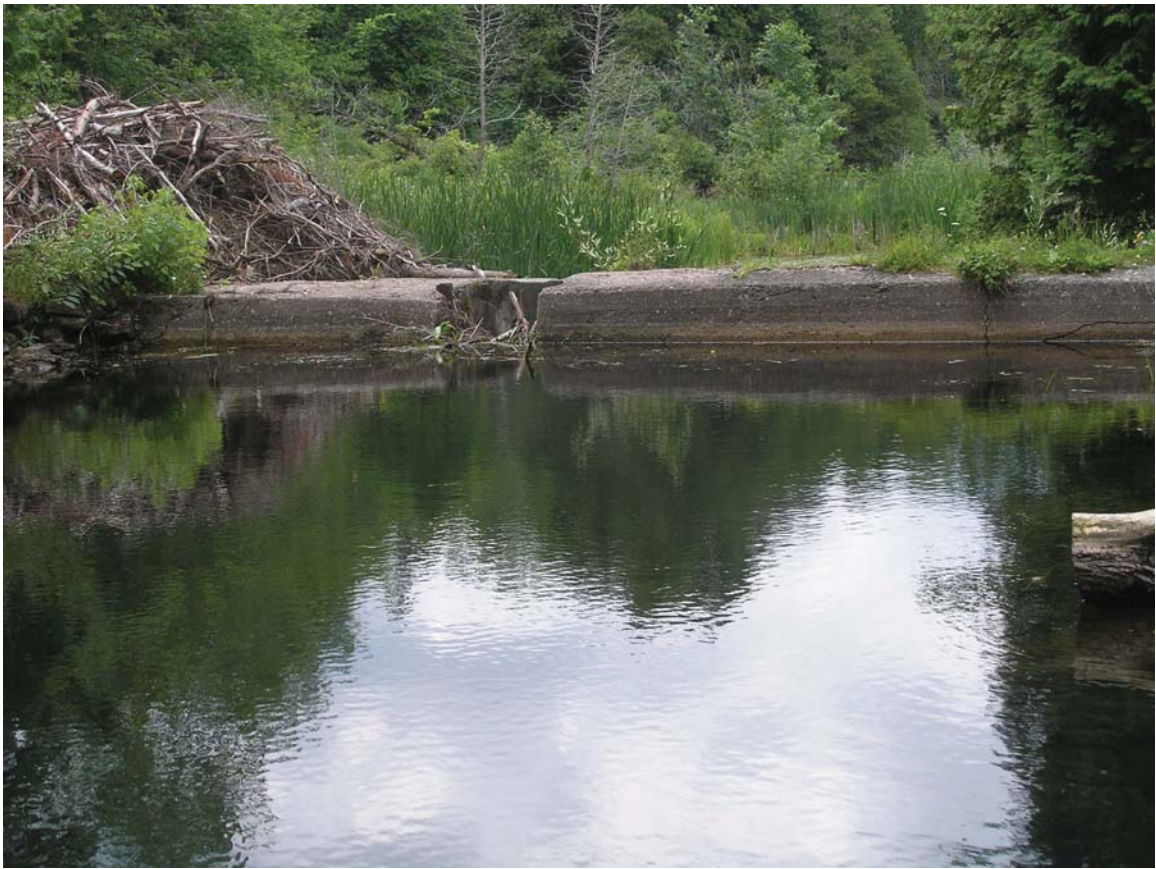
In the headpond sediment has accumulated to a depth of about 4' (Photo 5). Beaver activity is also evident as cuttings have either been placed by beaver or simply collected at the dam. A large pile of debris has been deposited presumably by the dam operator on the left embankment (Photo 1).

**Photo 1: Upstream View of Dam**

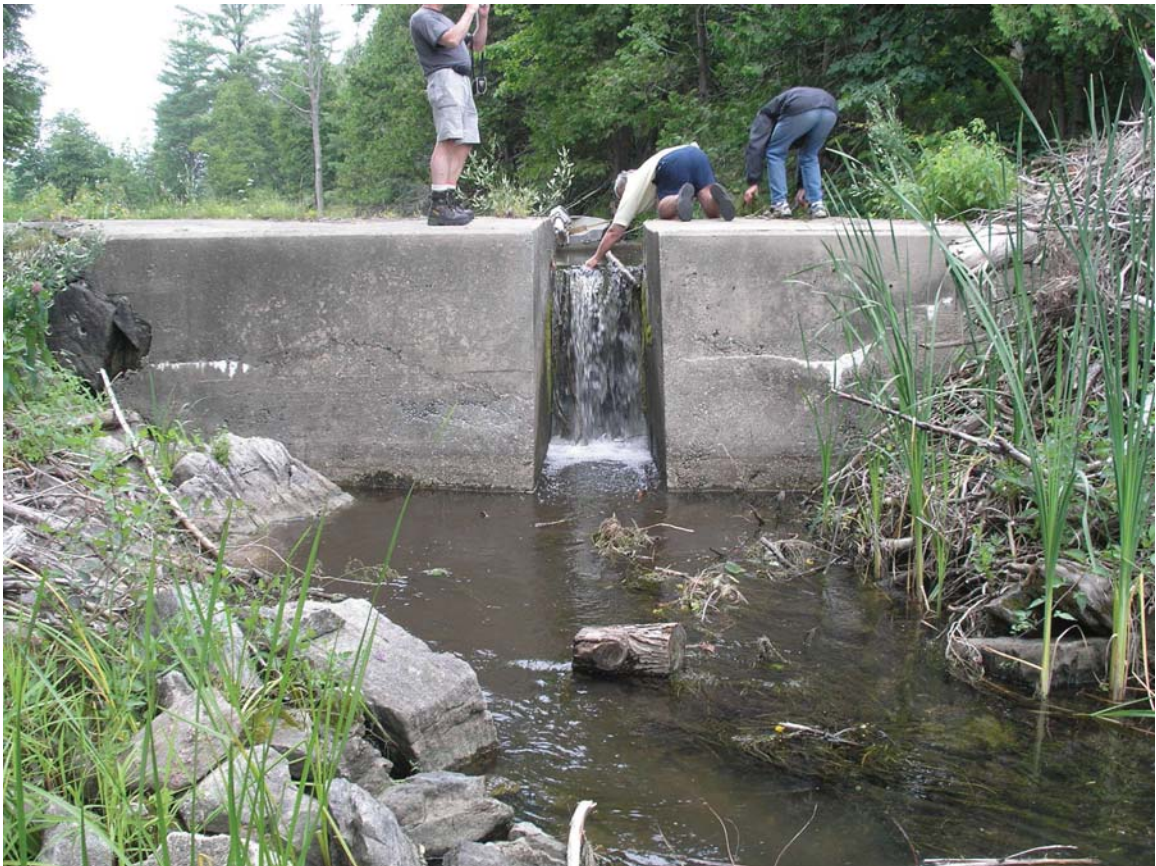
The downstream portion of the dam is in good condition. This section was constructed in 1994 to buttress up the dam. The left abutment upstream portion is in poor condition and has some significant cracks. In places there are cavities between the upstream face and downstream portion. Photo 8 shows the most prominent cavity.

**Photo 2: Downstream View of Dam**

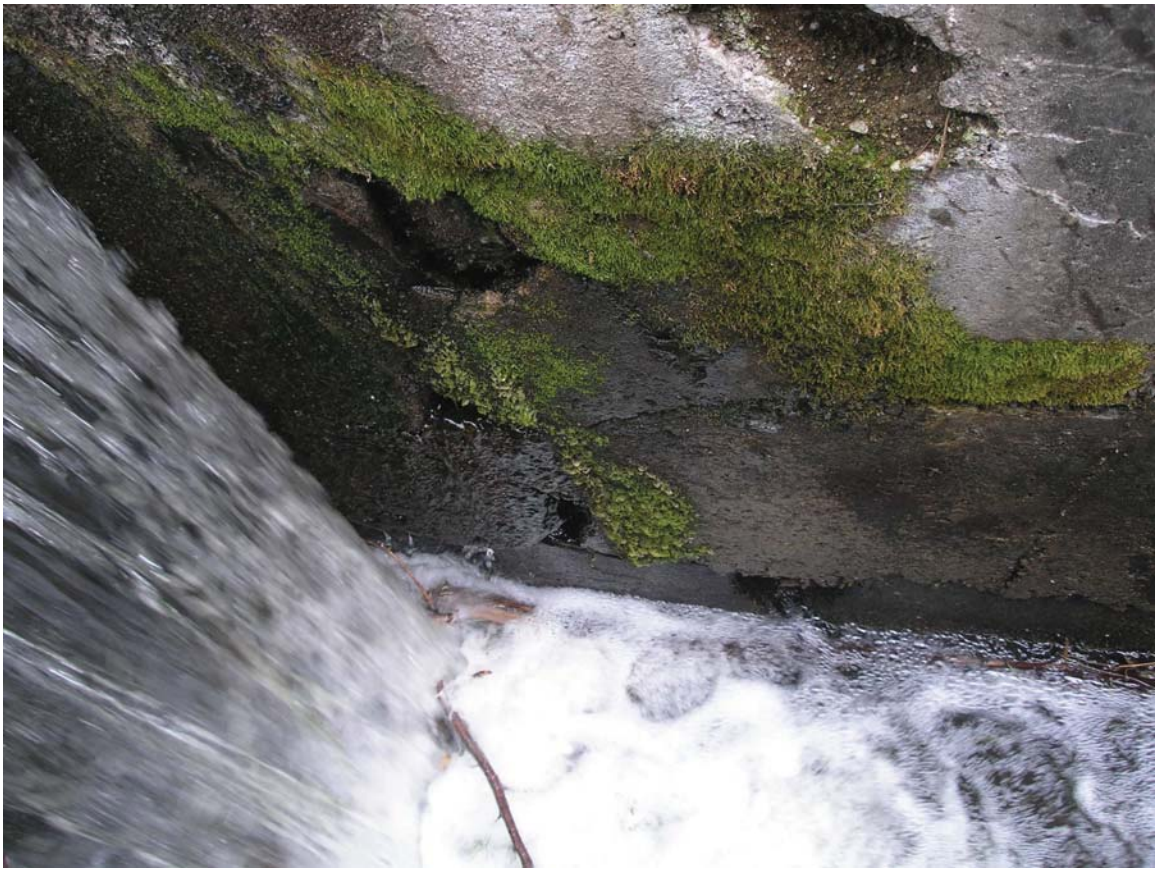
Within the sluiceway there is also some concrete loss and deterioration. This can be seen in Photos 3 and 4. Most deterioration is on left side (Photo 3) where some voids have developed.

The gains (log openings) are formed with steel angle embedded in concrete. The steel is in good condition where it can be seen. However, leakage through the concrete near the left gain is noticeable (Photo 3). We were not able to determine the condition of the logs, but they were holding water with relatively little leakage.

**Photo 3: View of Left Sluice Wall (Notice leakage and concrete loss)**

Concrete repairs should take place by chipping out the loose sections, particularly those over the old structure on the left embankment, to a depth of about 6". If possible, rebar should be dowelled into upstream and downstream masses to join these more cohesively. Approximately 7' x 5' x 6" deep of surface area should be chipped away and recapped on the top of the left abutment. Approximately 5' x 4' x 6" depth of loose concrete in the sluiceway on left side should also be chipped away and recapped.

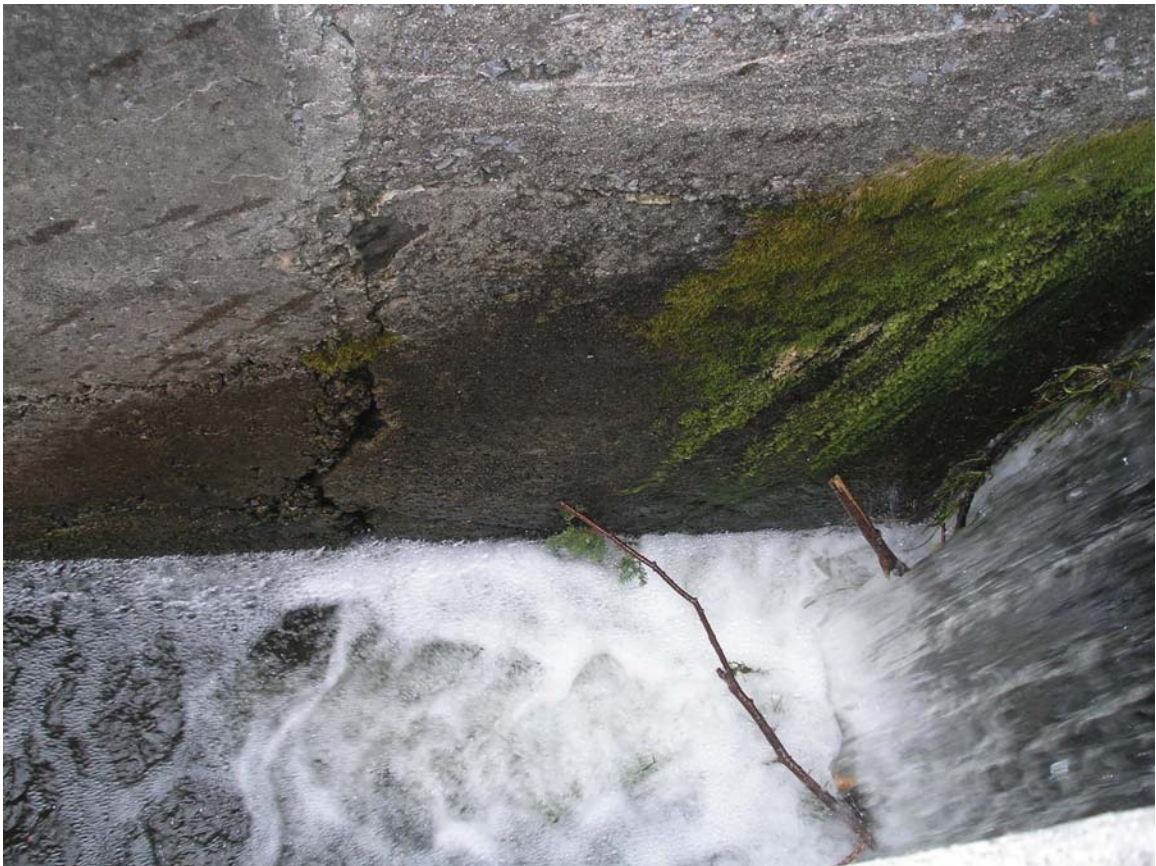
**Photo 4: View of Right Sluiceway (Vertical crack at joint)**

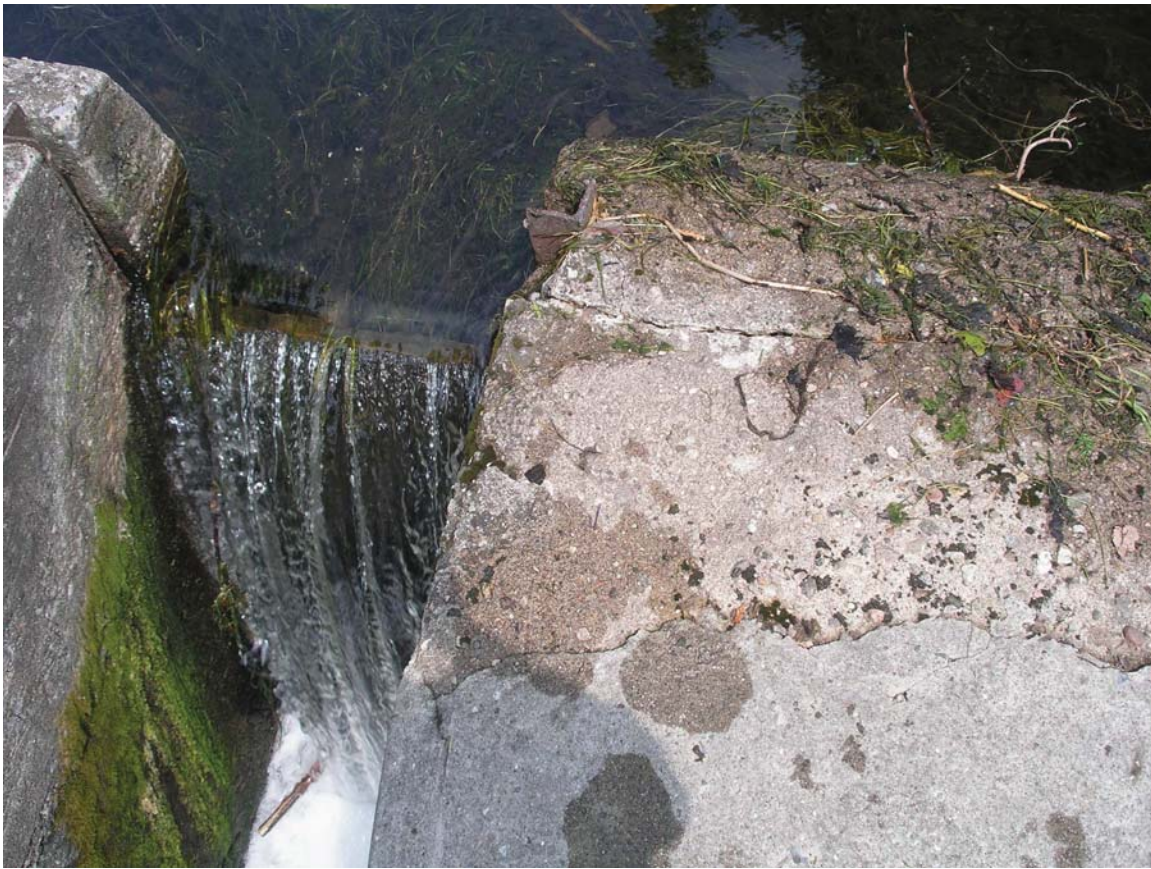
The joint between the former structure and the concrete mass added in 1994 is apparent in Photos 5, 6 and 9. There is some efflorescence at this joint. In places vegetation has taken root in the joint and voids in the older upstream portion (Photo 9).

**Photo 5: Log Bay (Concrete deterioration of left abutment can be seen)**

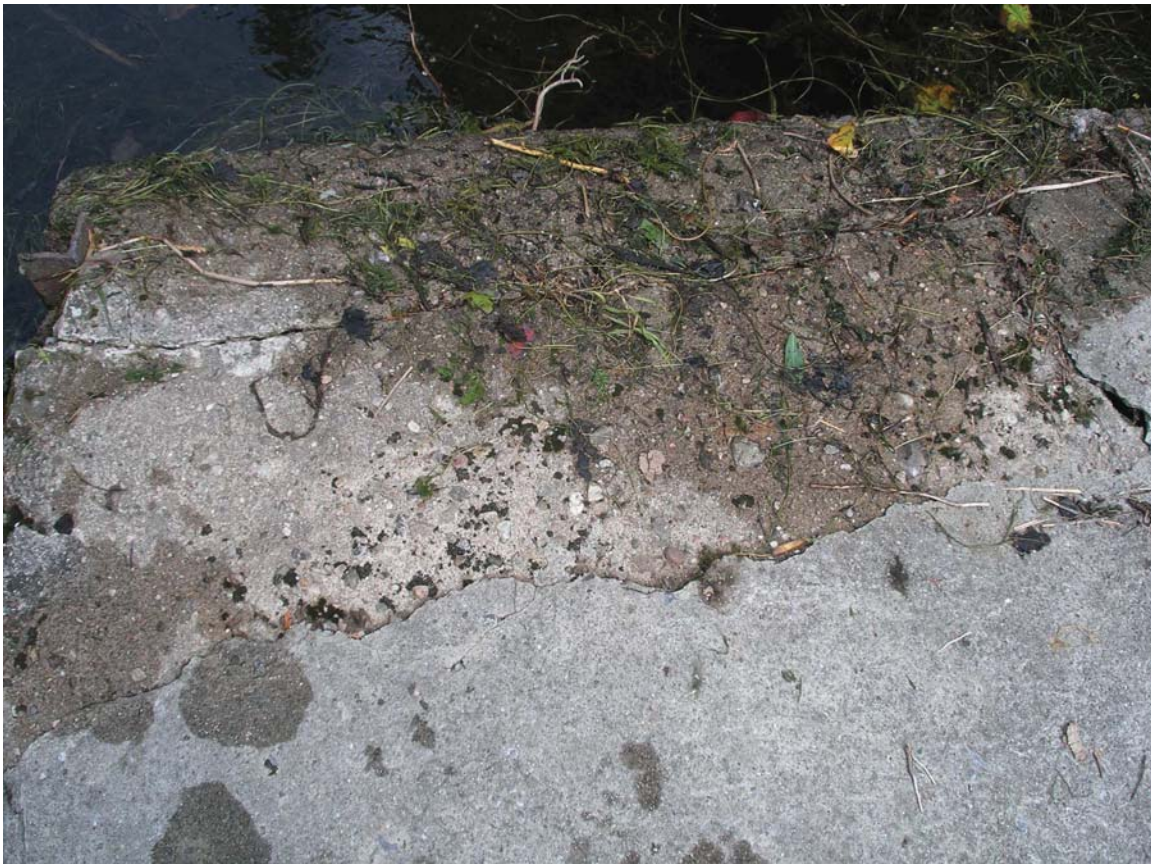
**Photo 6: Left Abutment Showing Deteriorated Concrete**

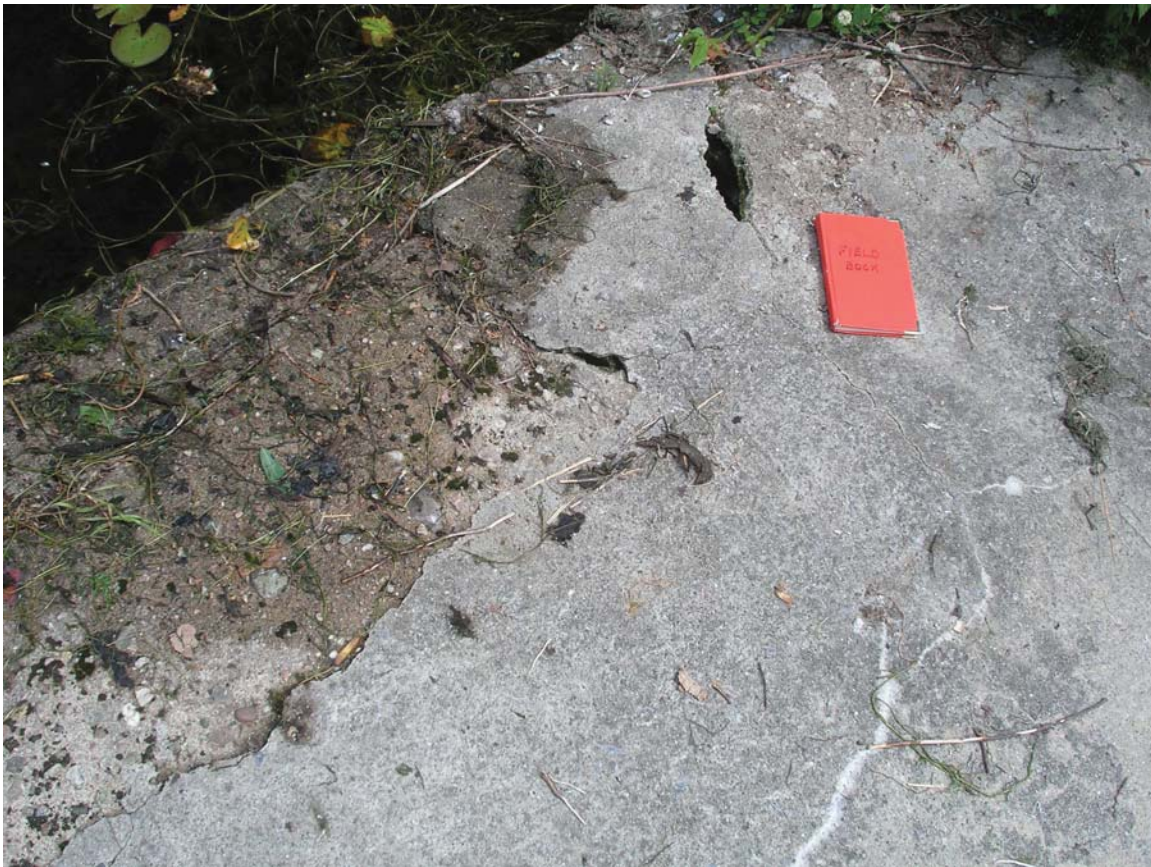
**Photo 7: Left Abutment Showing Location of Void**

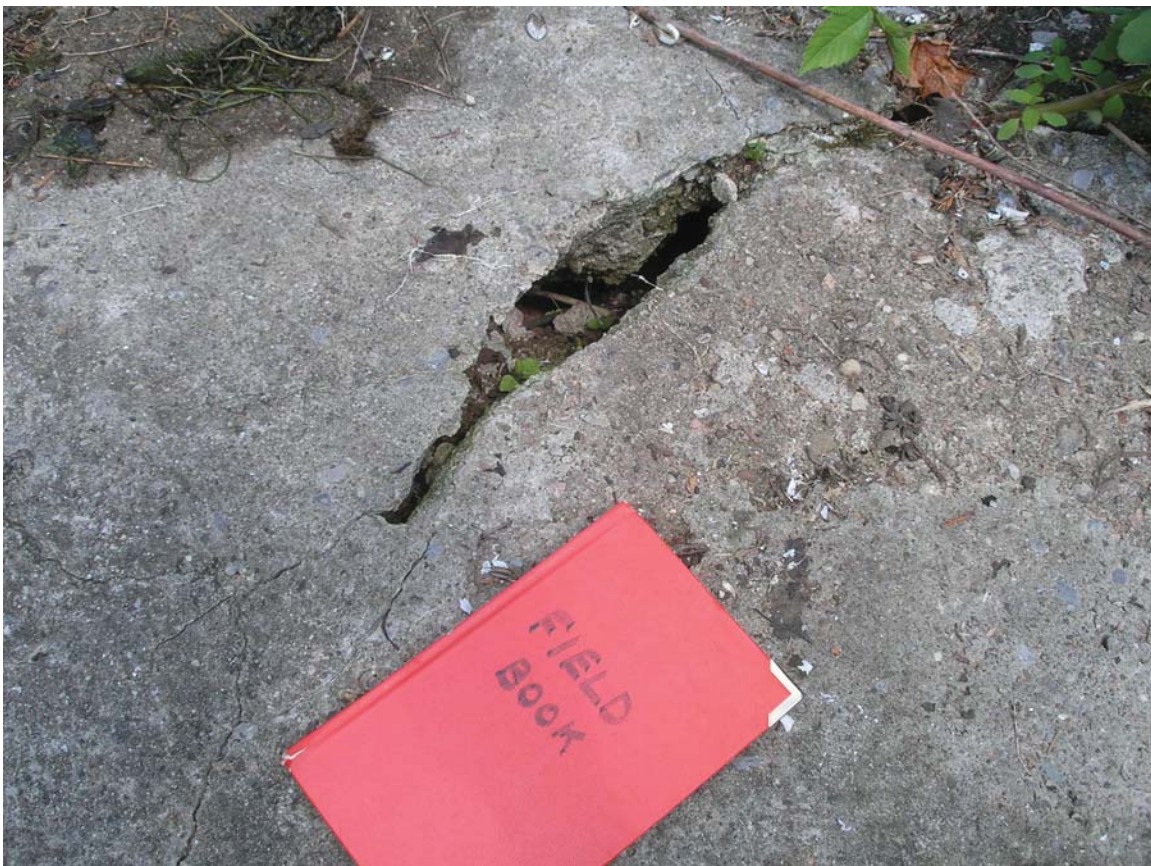
**Photo 8: Void in Concrete, Left Abutment**

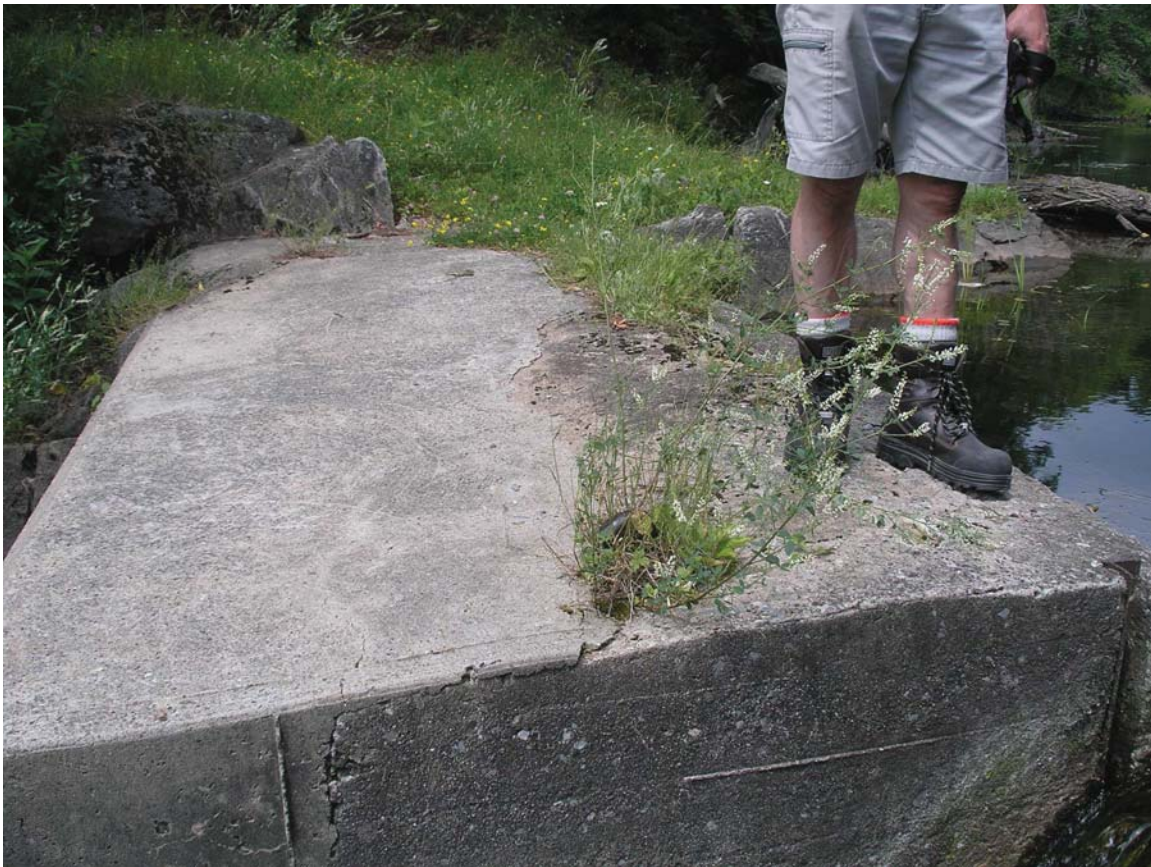
**Photo 9: Right Abutment (Upstream deterioration, vegetation growth)**

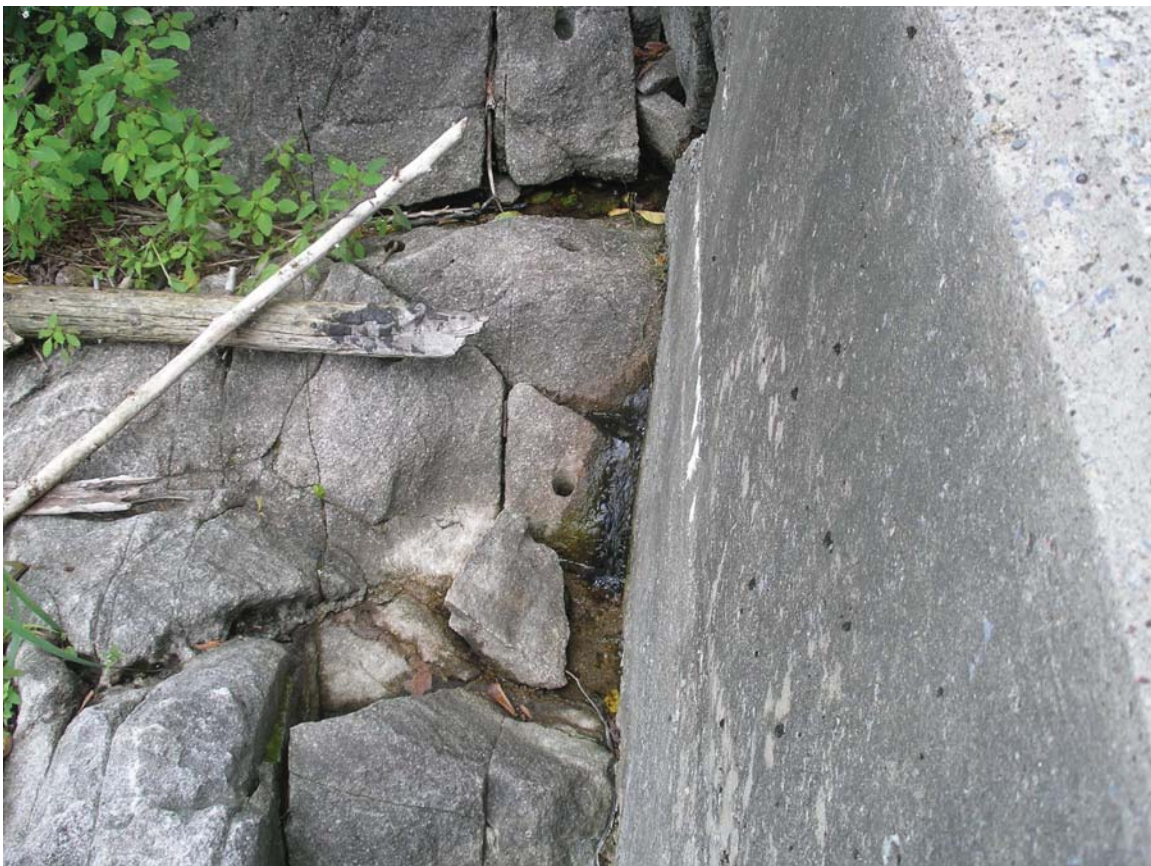
At the connection of the right abutment to the exposed rock foundation, some leakage is evident (Photo 10). Further downstream more leakage can be seen through rock joints (Photo 11). This is not significant. Leakage was not observed at the left abutment, however, the large pile of debris did not permit close inspection.

**Photo 10: Leakage through right abutment / rock interface**

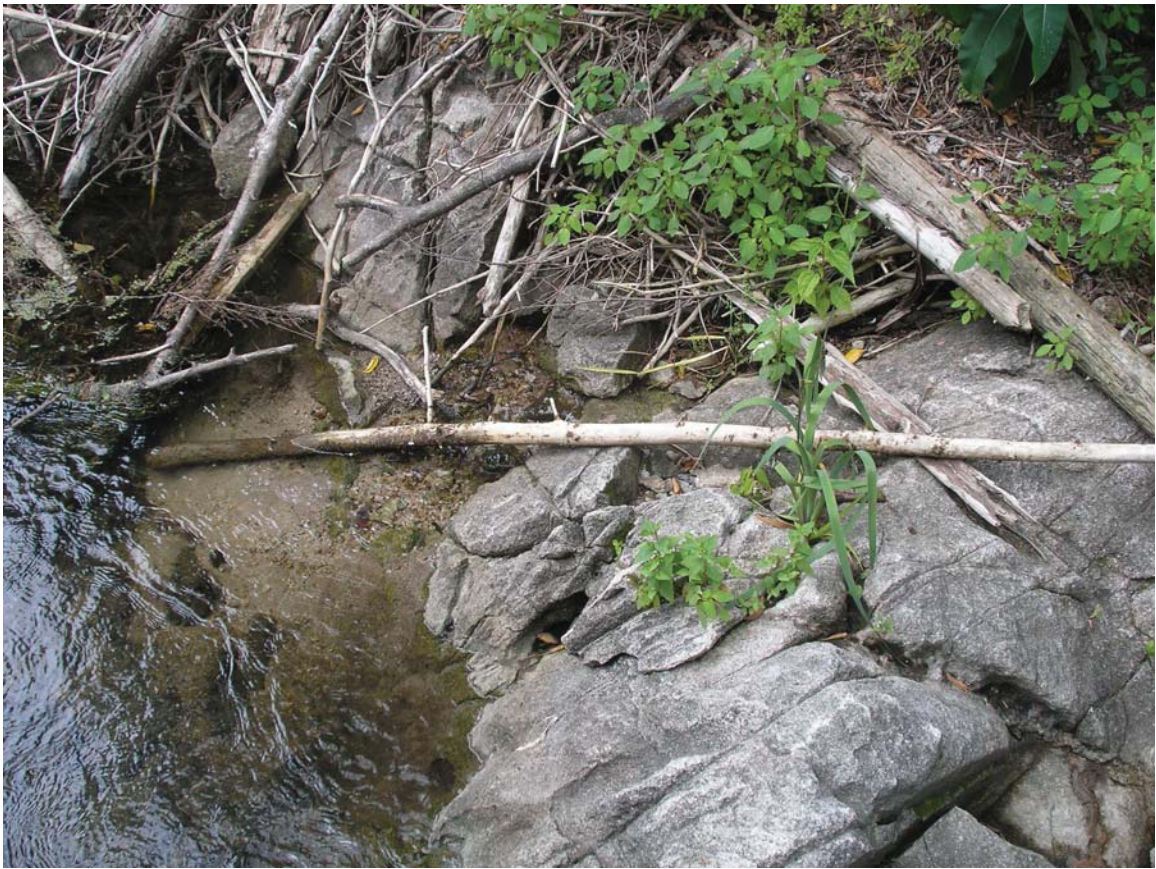
**Photo 11: Leakage through rock just downstream at right embankment**

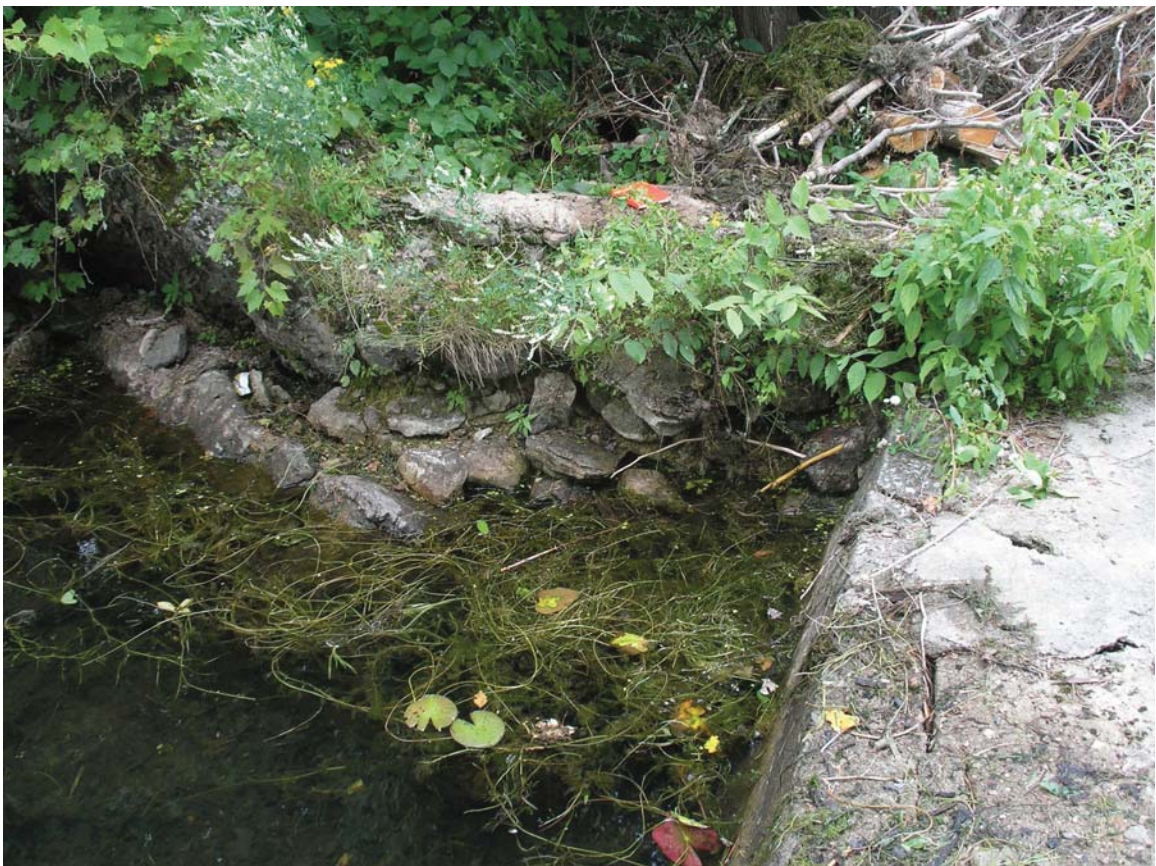
There is a side wingwall that has been placed presumably to reduce embankment damage during overtopping events (Photo 12). The wingwall is fabricated of masonry and is generally intact, but appears frail. Suggest this have some rip-rap material approximately 12" in diameter to provide support on downstream side and reduce potential for embankment erosion.

**Photo 12: Upstream bank protection left side**
