## 14 ISLAND LAKE DAM – INSPECTION MEMO

**Location:** South Frontenac

**Date:** August 21, 2019 – 13:30

**Written By:** Kelly Maher

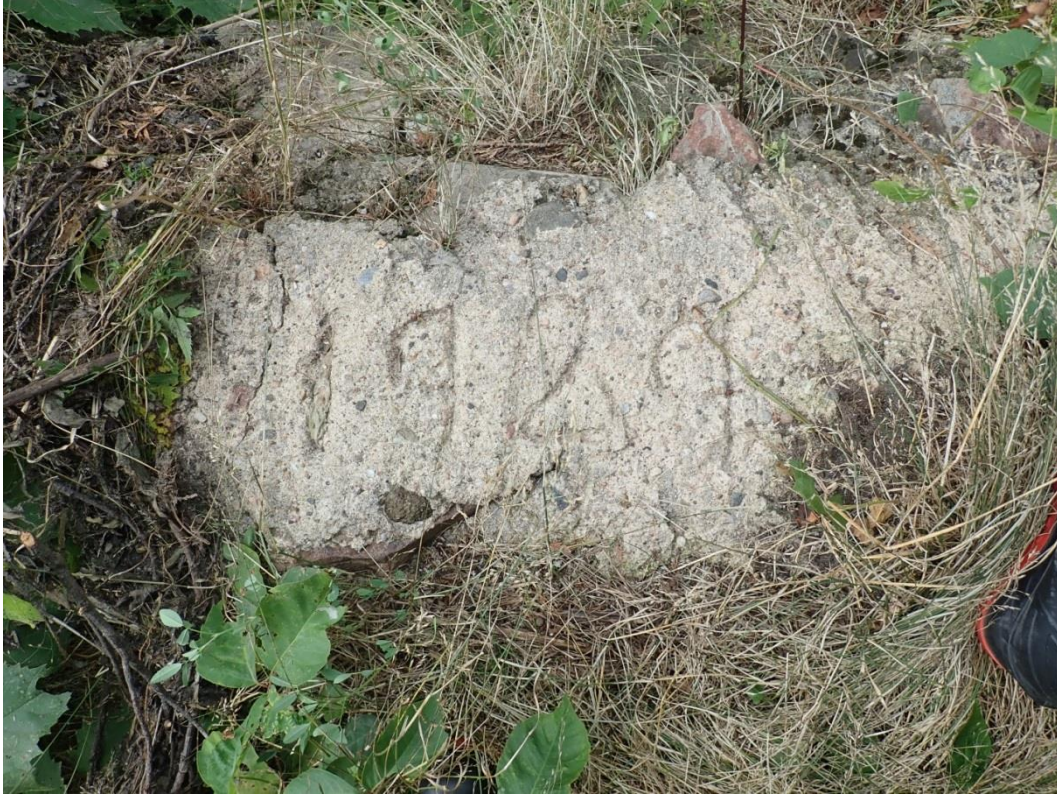
The date of construction of 14 Island Lake Dam is unknown however during our site visit this August it was discovered the year '1929' was carved in concrete on the left bank (**Photo 1**).

**Photo 1: Year '1929' carved into concrete on left upstream shoreline/bank**

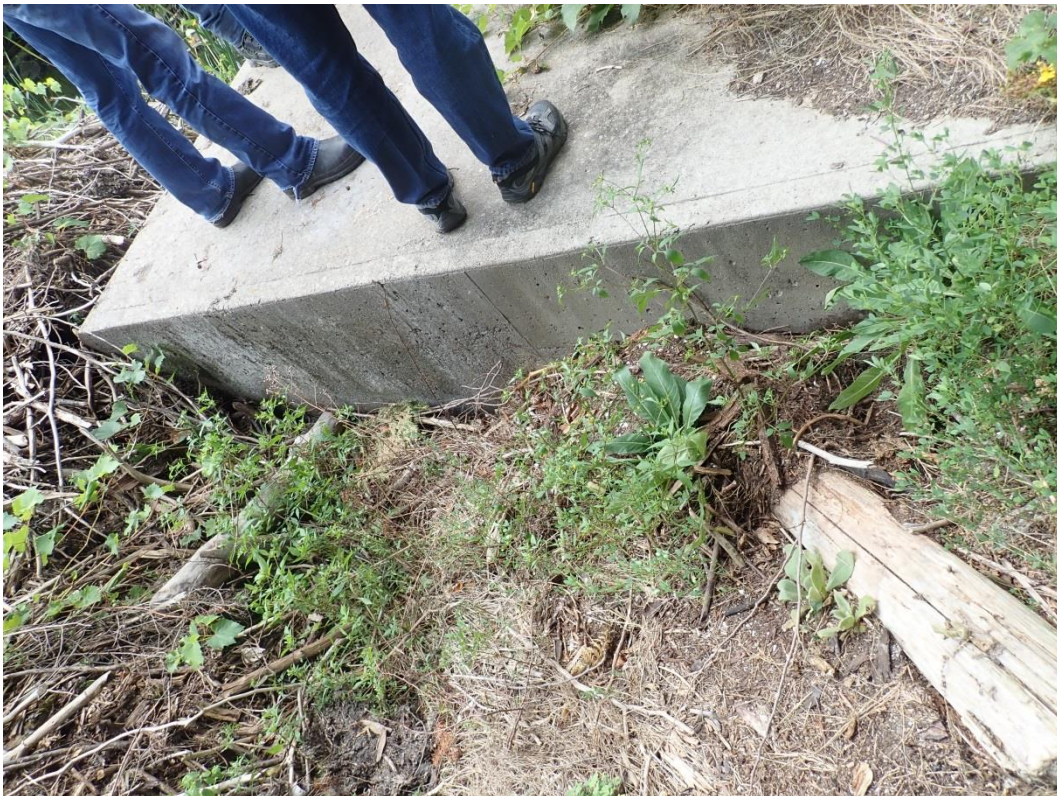
The downstream portion of the left side of the dam is in good condition. According to the 2009 Inspection Report this section was constructed in 1994 to buttress up the dam (**Photo 2, Photo 3**).

**Photo 2: Left abutment, downstream side - in good condition**

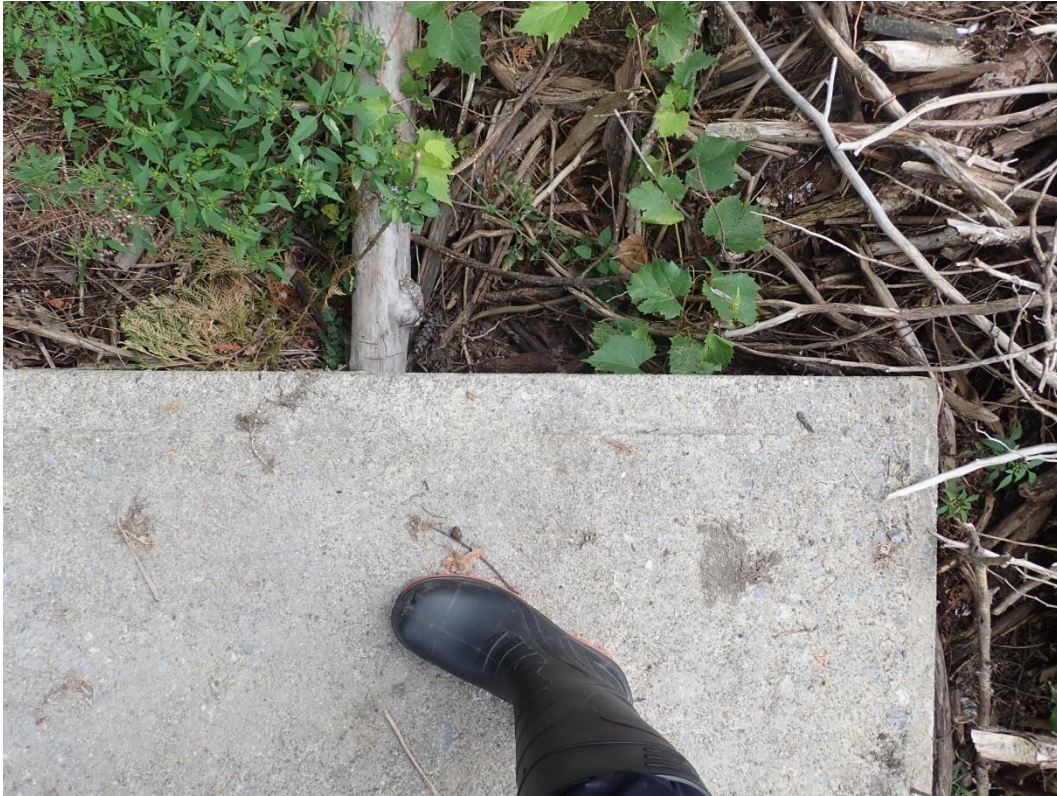
**Photo 3: Left abutment, downstream side - in good condition**

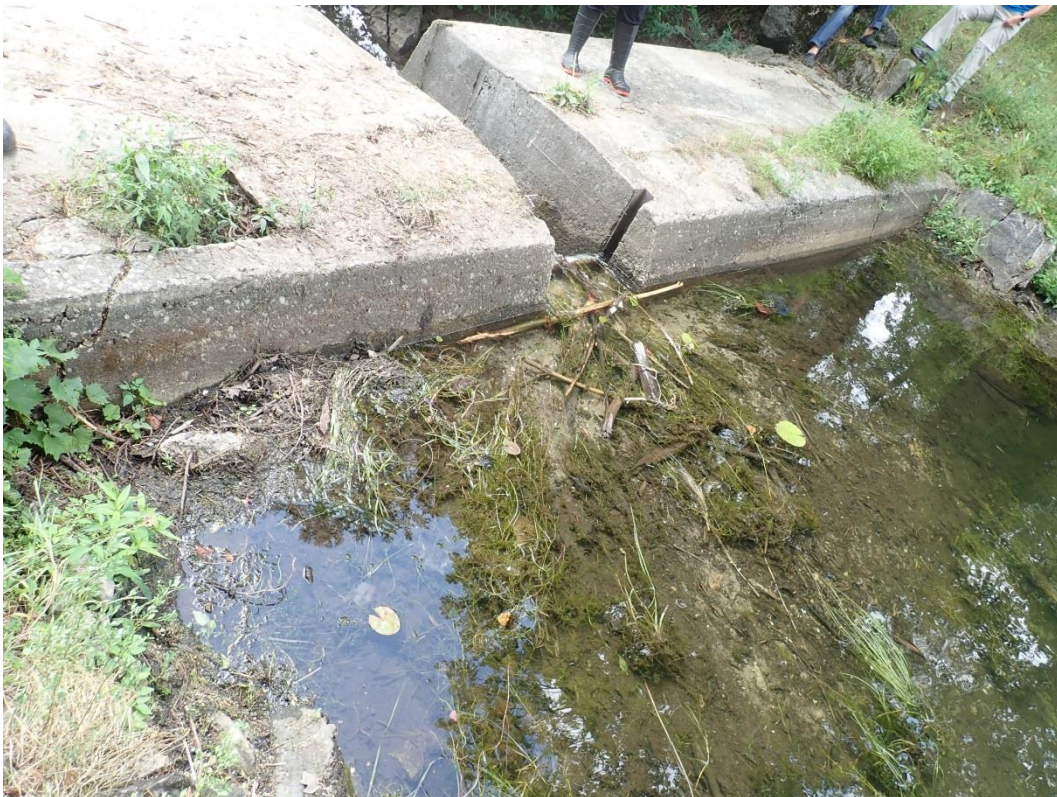
There is a noted difference between the new concrete on the downstream side of the dam and the original concrete on the upstream side. The old portion of the crest shows significant signs of heaving, voids, cracks, vegetation growth and loss of material and aggregate (**Photo 4, Photo 5**).

**Photo 4: Left abutment upstream and crest - significant voids and cracking**

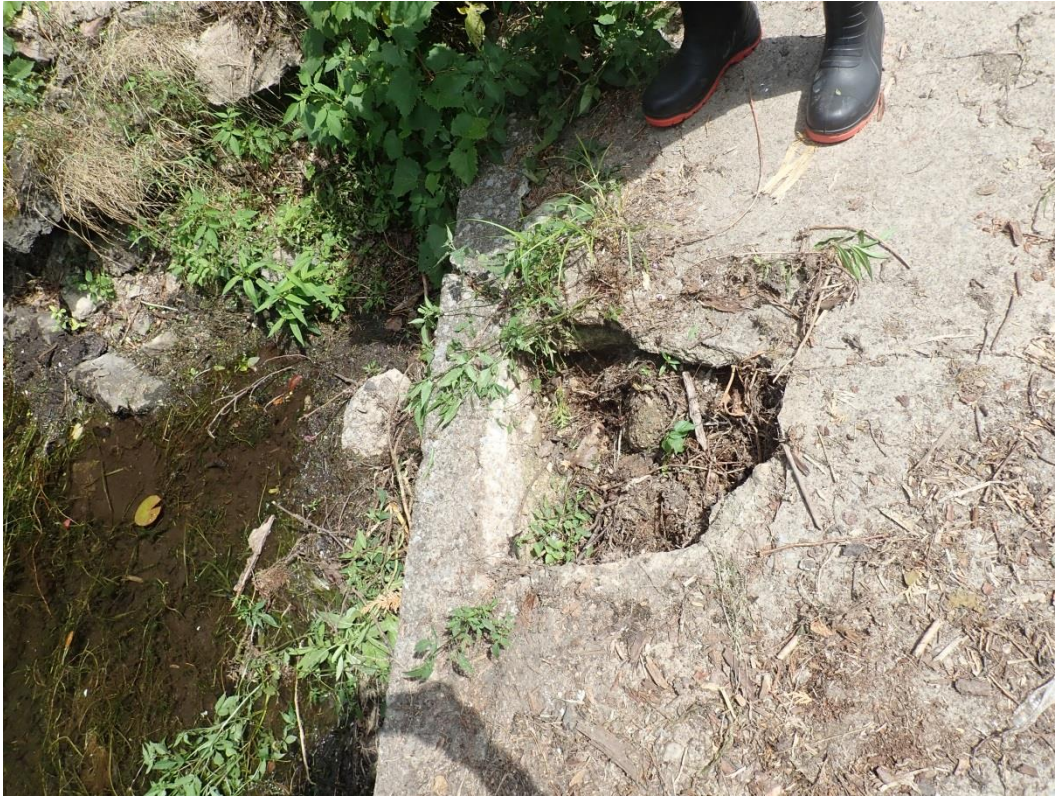
**Photo 5: Left abutment void**

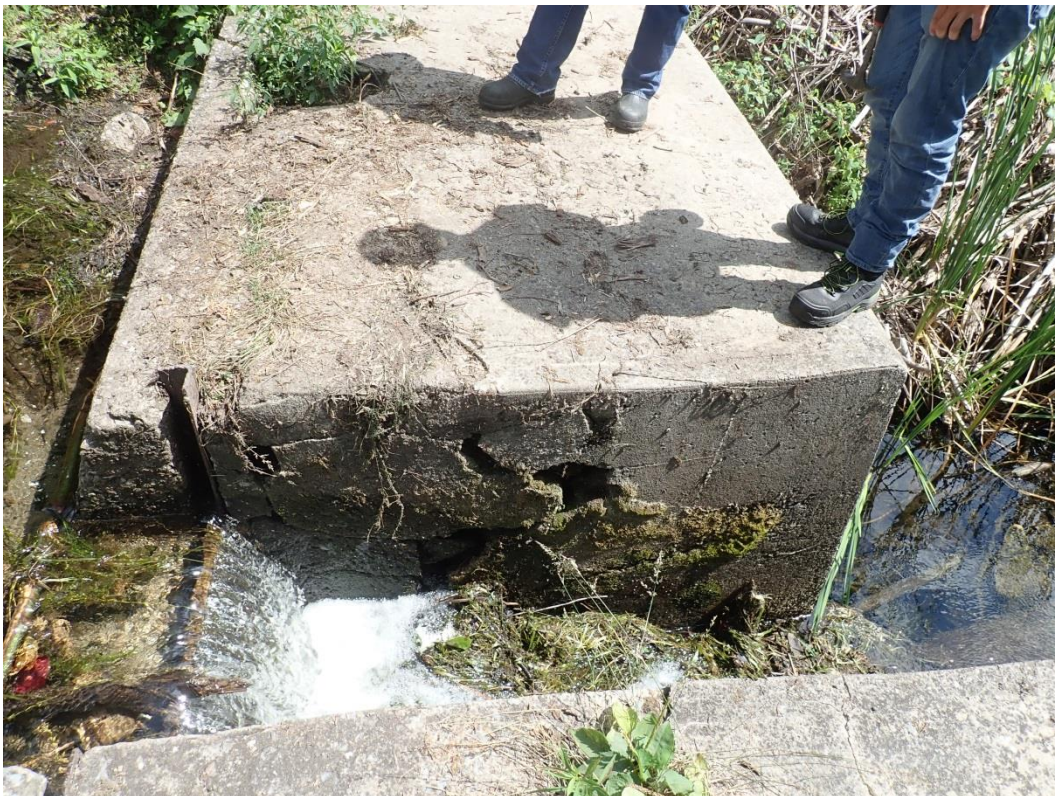
The gains (log opening) in the sluiceway are made of steel angle iron embedded in concrete. The visible parts of the gains above the water level are in good condition (**Photo 6**).

**Photo 6: Sluiceway, looking at the left inner wall**

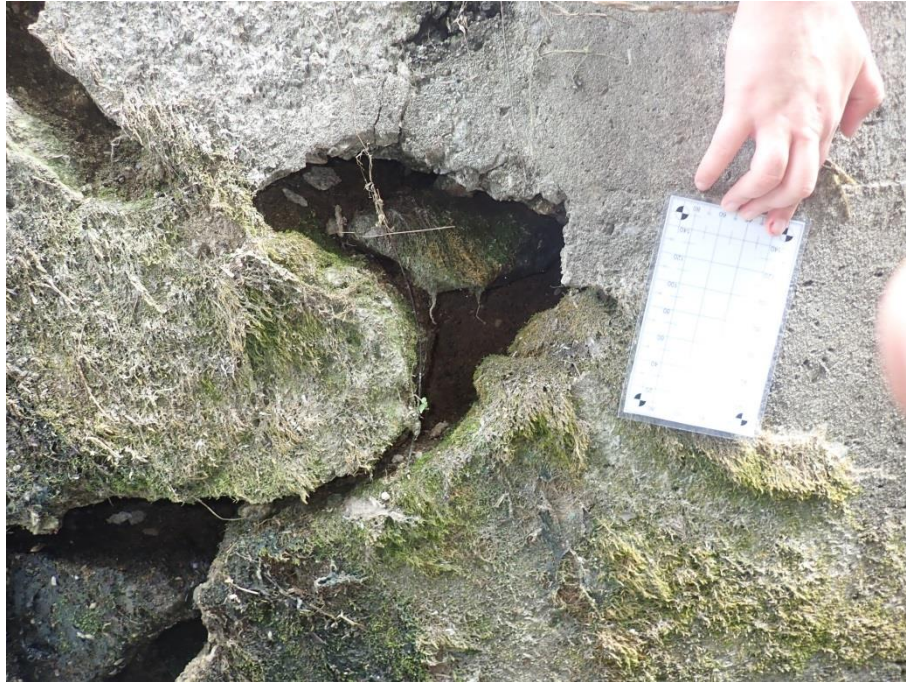
Within the sluiceway there is significant concrete loss and deterioration. Wet areas are noted in the sluiceway downstream which could indicate possible seepage or leakage through the concrete structure (**Photo 7**). The void in **Photo 7** on the left wall of the sluiceway was measured to be approximately 2.5 feet deep into the abutment.

**Photo 7: Sluiceway left inner wall – cracks, voids, loss of material and deterioration**

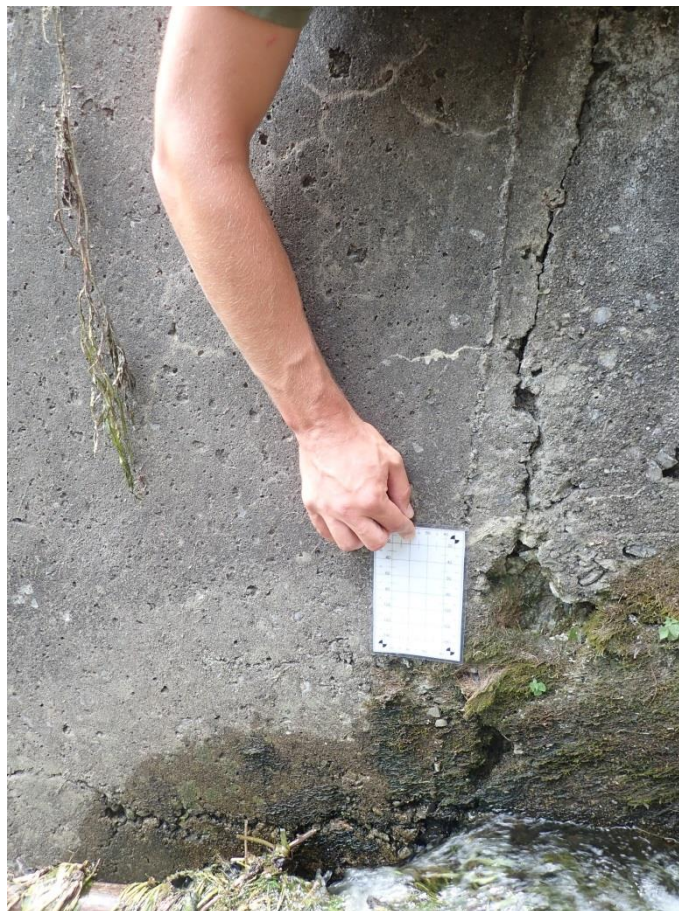
The inner right wall also had signs of material loss and deterioration of concrete. Wet areas were also noted on the right side indicating possible seepage or leakage through the concrete structure (**Photo 8**).

**Photo 8: Sluiceway right inner wall – cracks, voids loss of material and deterioration**

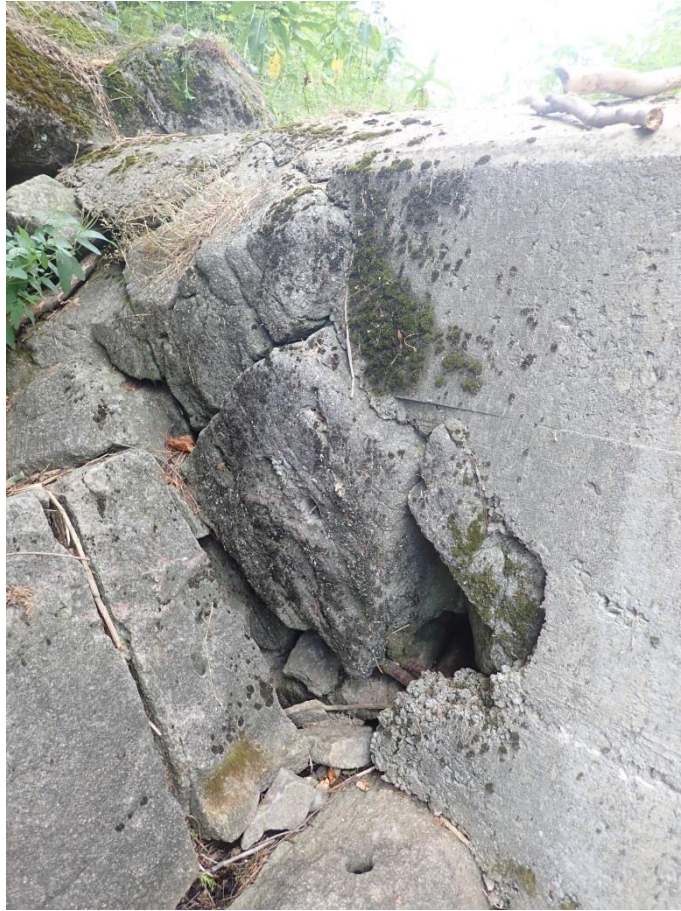
At the interface of the right abutment to the exposed rock foundation, there is loss of material and deterioration of concrete (**Photo 9**). The large void shows exposed rebar and was measured to be approximately 2.5 feet at its opening and 4 feet deep into the weir (**Photo 10**). At the time of the 2009 inspection, seepage was noted through this connection; however no visible seepage was noted during the 2019 inspection.

**Photo 9: Downstream view of right bedrock abutment interface**

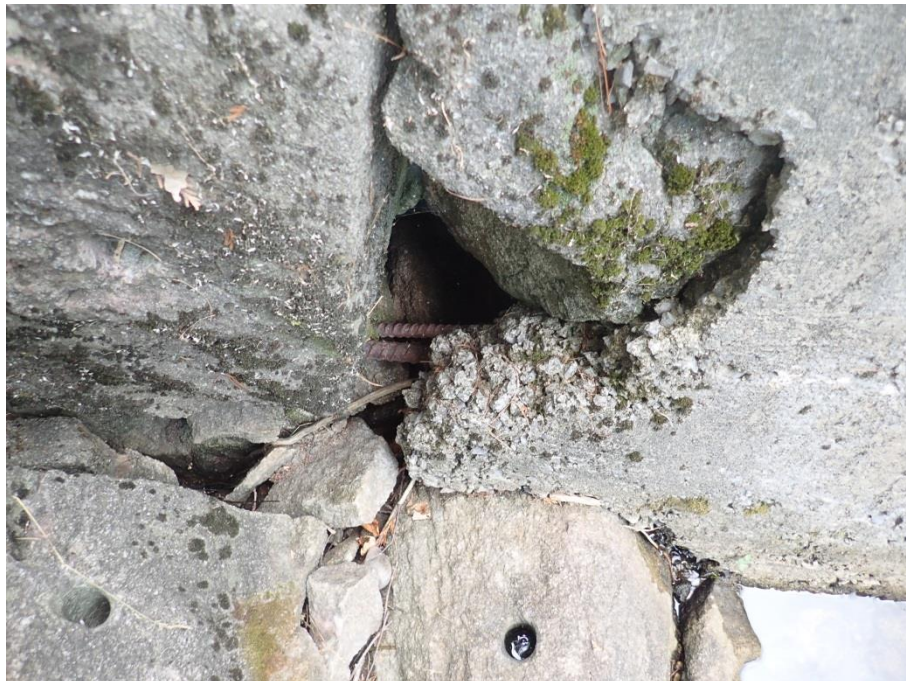
**Photo 10: Zoomed view of downstream right bedrock abutment interface**

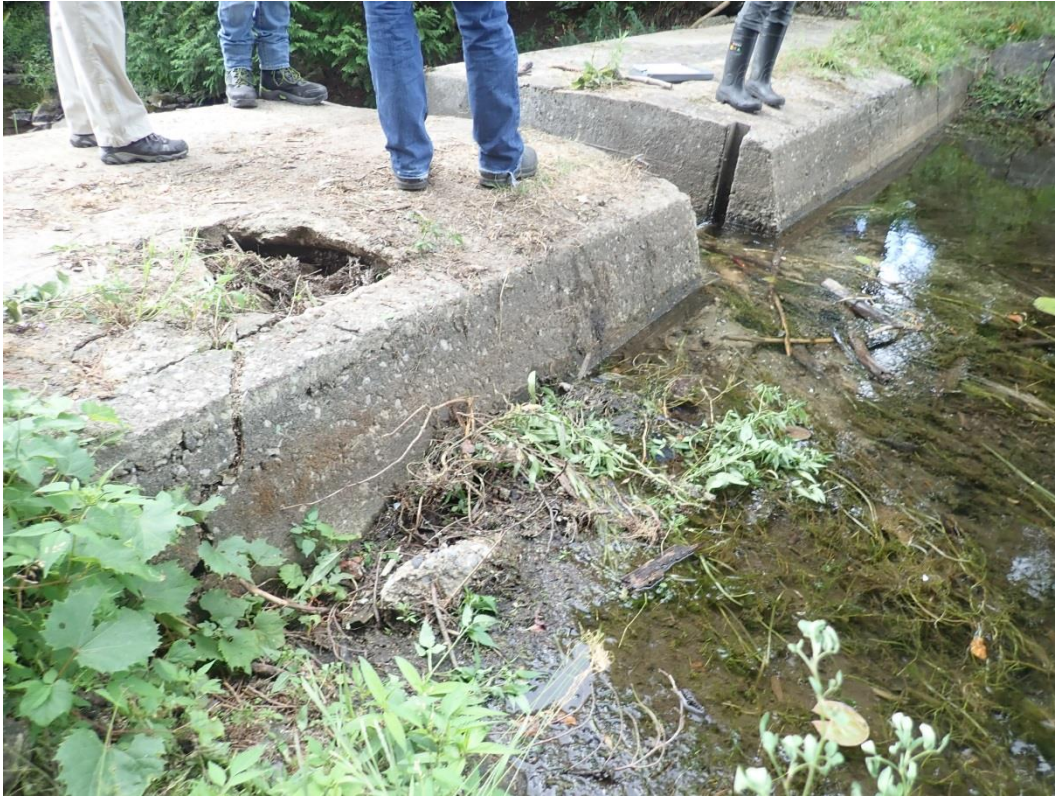
The upstream side of the dam has visible debris and sedimentation (**Photo 11**). On the downstream side below the left abutment, a significant amount of debris (logs from beaver activity) is stockpiled for removal (**Photo 12**).

**Photo 11: Upstream view of reservoir debris**

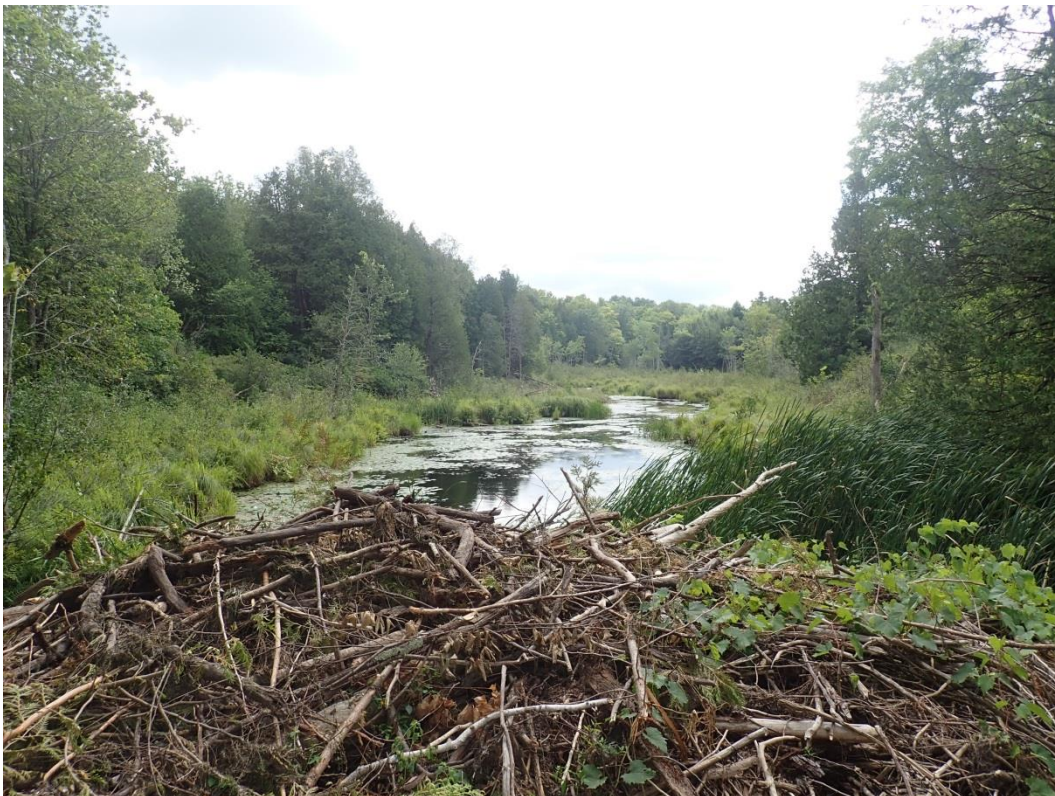
**Photo 12: Downstream view of stockpiled debris from beavers**

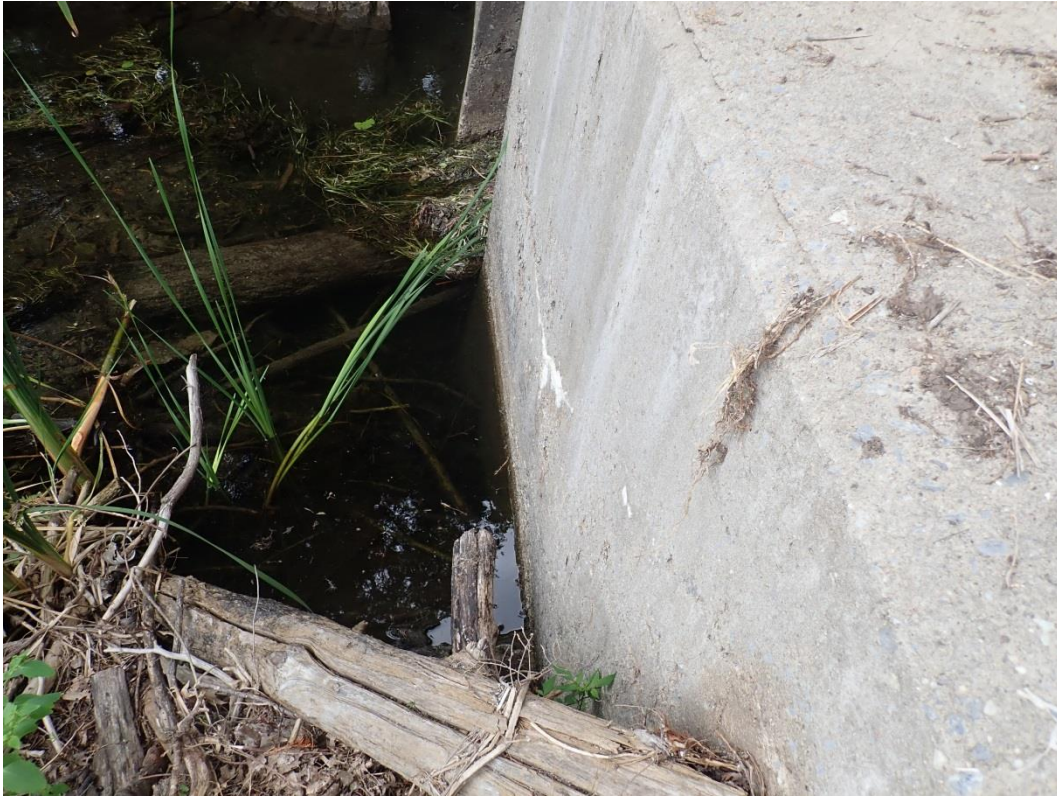
On the downstream face of the dam on either side of the sluiceway a horizontal crack was noted with visible efflorescence (**Photo 13**). Efflorescence is a process where salt migrates and crystalizes onto the surface of a porous material. This reaction can indicate seepage coming through the structure and should be monitored.

**Photo 13: Visible horizontal crack with efflorescence**

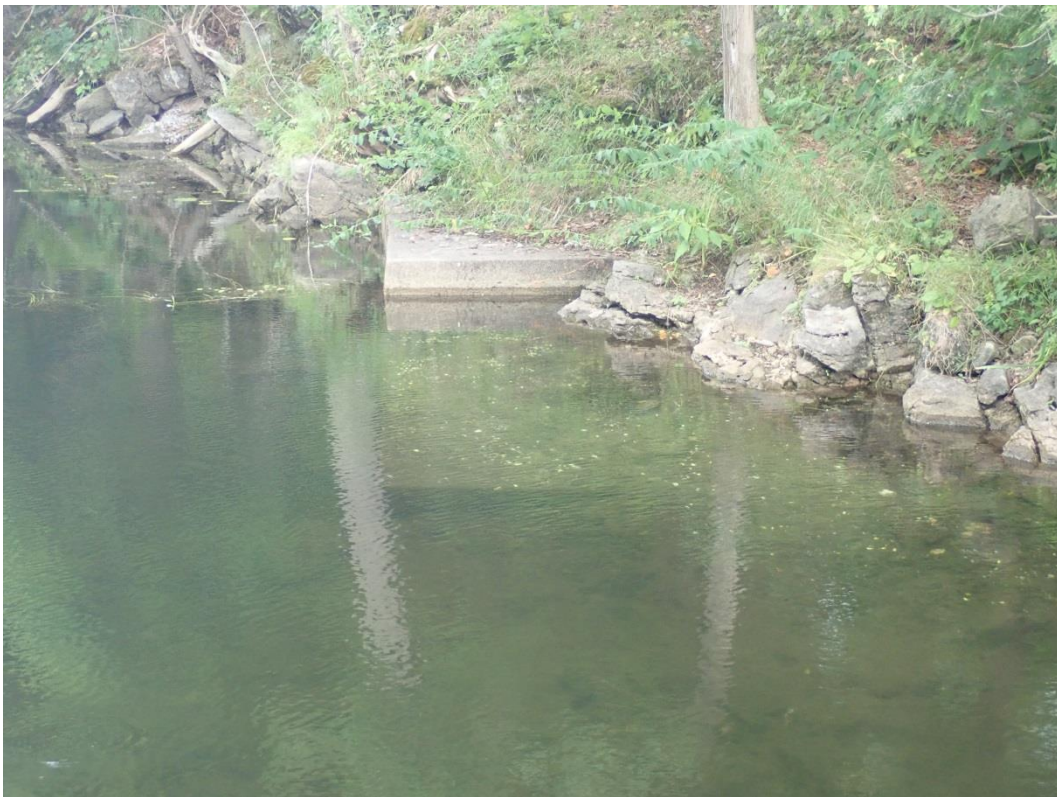
During the inspection two concrete pad structures were noted upstream on the left shoreline approximately 20-30 feet from the dam. One structure was submerged while a portion of the other was visible above the water line (**Photo 14**).

**Photo 14: Upstream concrete structures**
